JOINT TOURISM COMMISSION AND HISTORIC PRESERVATION COMMISSION  
MEETING MINUTES - DRAFT  
VILLAGE OF NEW GLARUS  
11/13/2018

### Heritage Preservation Consulting, LLC

# Chalet of the Golden Fleece Museum Historic Conditions Report

Observation and commentary offered here are based upon the condition assessments conducted on October 21, 2014. Preservation Architect Charles Quagliana reviewed the exterior elements, Kurt Straus, Structural Engineer, reviewed the structural components and Peggy Veregin, preservation specialist reviewed the interior.

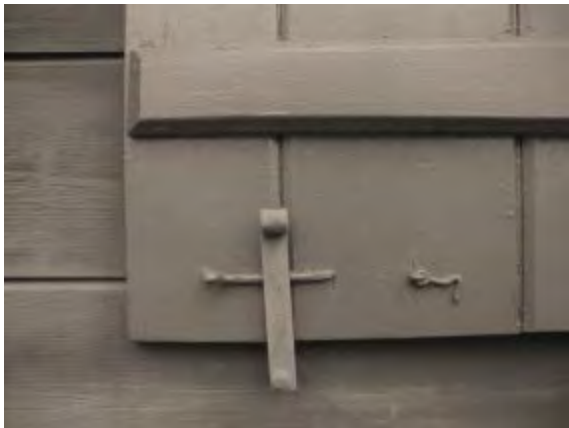
Image 1.1

*Detail at window shutter*

The shutter and associated hardware are generally in good condition. Only three shutters were noted to need repair work and these are on the first floor.

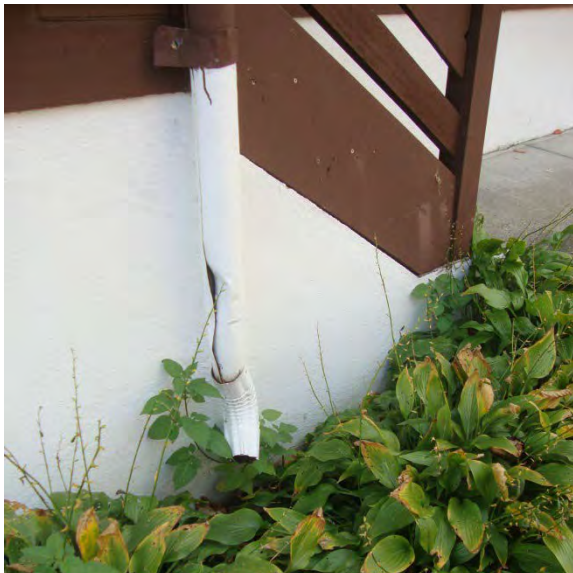
**Image 1.6**

Also contributing to moisture migration into the basement walls is the lack of storm water management at the downspouts from the roof. These typically empty at the base of the building, without run outs, allowing additional water to pond here and to find its way into the foundation walls.

*Typical downspout without run out.*

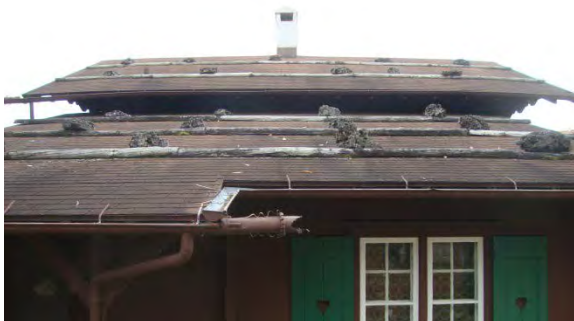
Image 1.7

The roof has 3-tab asphalt shingles in the range of 15-20 years old. They are beginning to loose granules and curl indicating they have just a few years of service life remaining before replacement is necessary. Moss and lichen are apparent on the north slope of the roof. These tend to accumulate in damp, shaded areas and aid in deterioration of the shingles and reducing the life of the roof.

There are areas of isolated deterioration at the soffit along the north roof edge. It appears that ice dams are allowing water to penetrate this area and cause wood deck deterioration. Water from the ice dams is also causing significant deterioration of the upper portion of the exterior wall at the north porch entrance, to the left of the door.

*Partial view of the north slope of the roof*

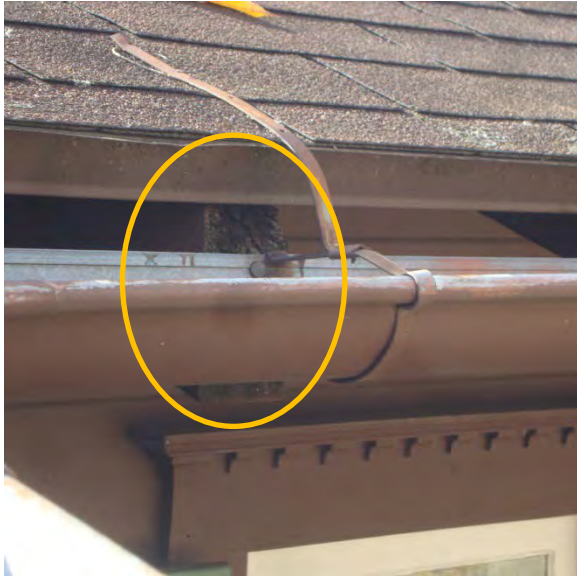
**Image 1.8**

The rafter ends are exposed and are deteriorating. The end grain of the wood that is exposed absorbs moisture and this facilitates dry rot. Most rafter ends are in good to fair condition and repairable. A few, especially at the end rafter locations, are in poor condition and will require substantial intervention.

*View of deteriorated rafter end (behind gutter)*

Rafter ends along the roof gutters were somewhat deteriorated. A couple of ends were significantly deteriorated. Deteriorated roof sheathing along the gutter was also noted. It is assumed that cycles of splashing roof rainwater runoff and contact from melting ice and snow has led to this damage.

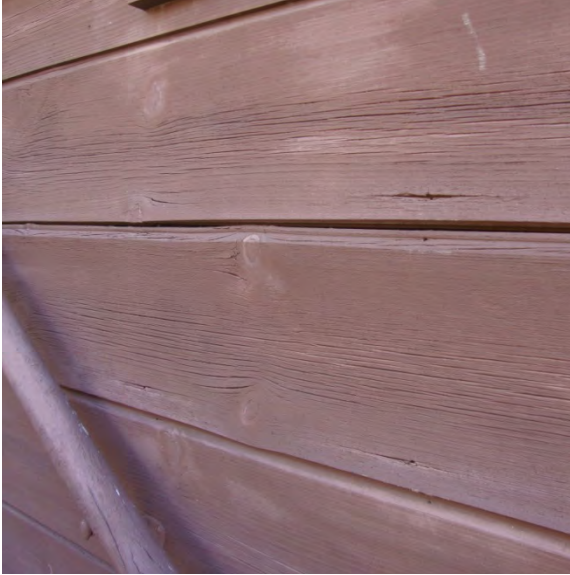
The siding is in very good overall condition with some isolated areas of significant cupping and minor deterioration. The cupping is most noticeable on the west side of the building below the living room windows. This happens when the outside surface of the siding loses moisture and shrinks, but the inside face does not follow. This is caused by lack of adequate finish on the wood and resulting open grain absorbing moisture. As the siding cups it opens the joint to the next piece of siding possibly permitting rain water to enter the joint creating further issues.

**Image 1.9**  
*Cupping and open grain of siding on west façade of Chalet*

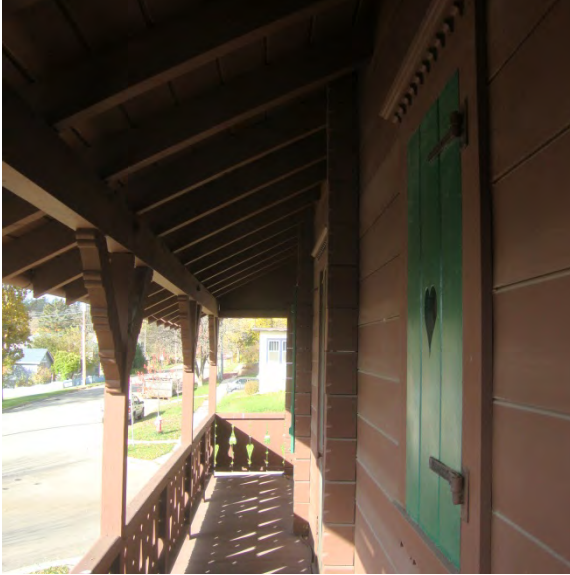
The balconies are one of the key picturesque elements of the house. Overall the railings, posts and roof framing of these are in good condition. The deck of the balconies is in fair to poor condition. The deck boards have deteriorated significantly on the east side and at the southeast corner. These areas are unsafe to walk upon. The railing tops at the south are weathered and in need of repair.

**Image 1.10**  
*View of the south balcony*

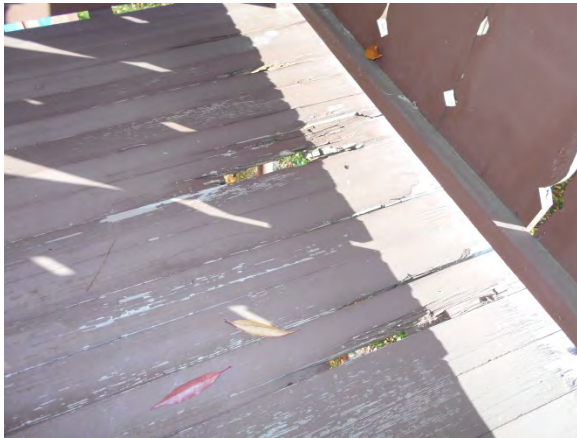
**Image 1.11**  
*View of the deteriorated balcony deck at the east*

The 1x fir second floor veranda porch decking was deteriorated. Public access to this area should be restricted until repairs are made. The steel posts supporting the second floor balcony porch are obviously an addition. The steel posts supporting the balcony appeared to be quite slender. Their condition appears to be good; their placement is grandfathered (exempt from current codes and standards). They should remain in place until the balcony is repaired/replaced.

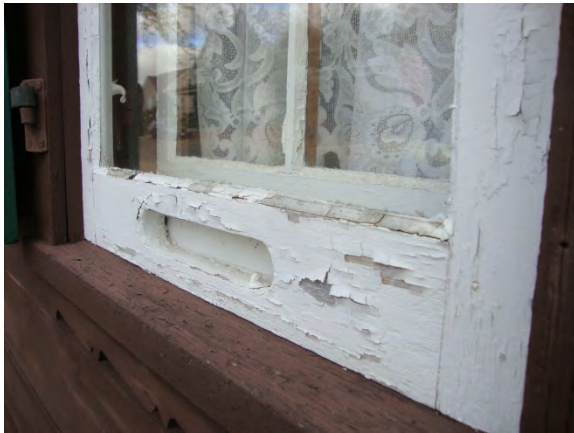
**Image 1.12**

The window sizes vary from 8 to 6 to 4 pane units with moderate size muntins and mullions typical of the 1930s. The sash are in fair condition with deterioration at the lower rails and stiles typical as well as poor glazing of the glass. There is a general loss of paint finish both exterior and interior on most windows. The storm windows are in fair to poor condition with significant deteriorated paint finish and glazing.

All sills are in good condition with some level of minor deterioration of the surface related to paint and weathering.

*View of a west facing storm window and window sill*

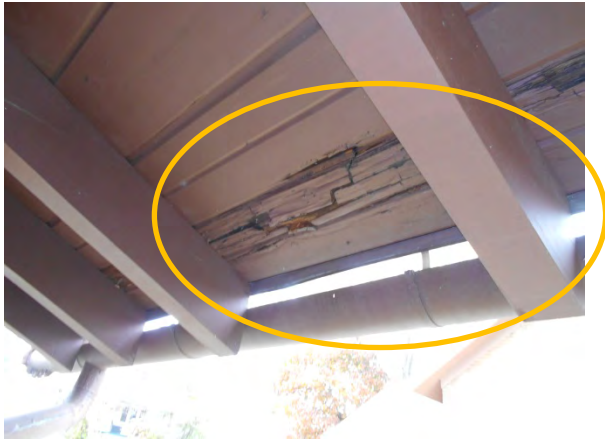
**Image 1.15**

Leaking in the roof was noted in the attic over the kitchen. The leaking appears to have run down the underside of roof rafters to the wall of the side entry to the kitchen. This is likely the leak that has led to the damage in the wall at the kitchen side door entrance. This further describer below. The roof sheathing appeared to be in generally good condition; fair condition in the area of the leakage.

*Deteriorate roof decking/soffit at side porch outside the kitchen*

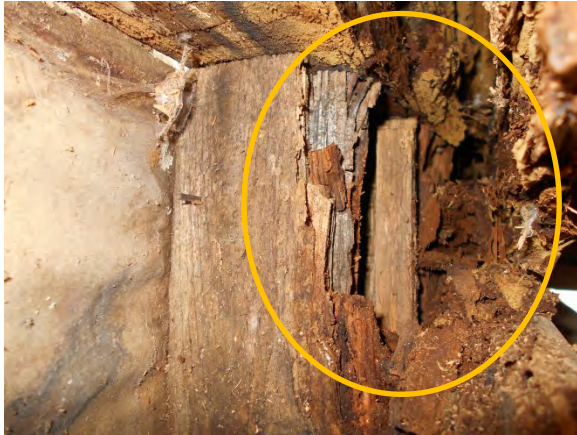
There was an area of damage noted on the exterior wall over and next to the exterior side entrance door to the kitchen. It appears that the damage was caused by the leaking roof in the attic trickling into the wall cavity. Significant damage was present in the studs, sheathing and siding in the wall. The area affected appeared to be approximately 20 square feet of wall surface. We were able to see inside the cavity and pull away sections of damaged wood framing.

**Image 1.16**  
*Deteriorated exterior wall at kitchen*

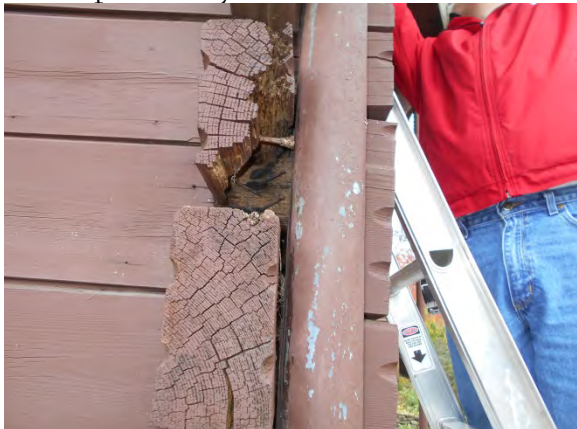
**Image 1.17**

The built-up vertical wall bracket stacks of timber are configured in incremented lengths to form a wood corbel reaching out to the edge of the roof. These stacked brackets are not performing well. In each of this bracket type, significant sagging was noted. Rotation was noted in the brackets, particularly at corners, as well as some separation in the joints in the stacked segments.

Portions of the built up stacked timber segment extensions are deteriorated. There is some concern that there may be deterioration in adjacent studs where water may have become trapped behind the timber blocks, particularly in lower areas of the walls.

## *Deteriorated end of timber extensions*

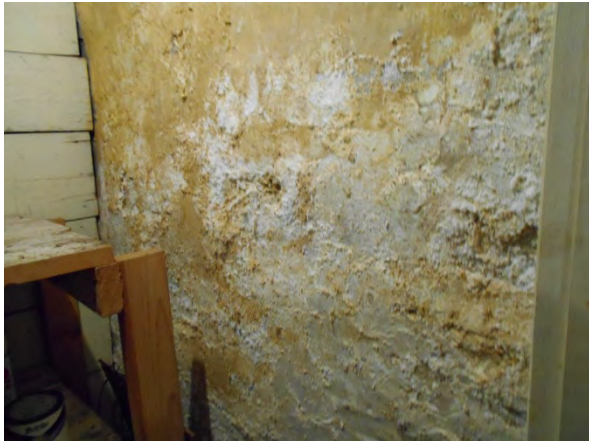
**Image 1.18**

Extensive efflorescence and moisture infiltration was noted on the foundation walls. There were many areas where plaster and paint coatings were delaminating and falling on the floor. There are likely ongoing delamination occurring on inaccessible surfaces behind finished walls and built-in shelving and casework. Extensive staining was present in the oak floors on the basement floor slab, also likely due to moisture infiltration or even seasonal condensation from moist air on colder surfaces. There may even be some deterioration concealed on bottom surfaces in the wood floors.

*Signs of moisture migration through the basement foundation walls.*

To mitigate the excessive moisture in the basement, there are three options. The first is to do nothing and simply monitor the conditions on regular intervals over time. The placement of coatings on wall surfaces will not solve the moisture issues; the moisture in the walls will continue to cause applied coatings to delaminate from the stone walls.

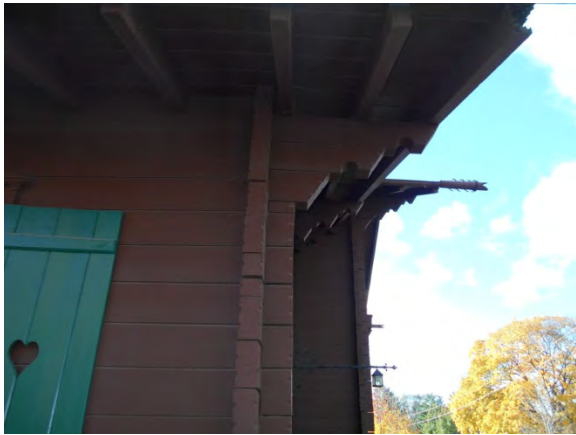
**Image 1.20**

*Sagging bracket at the southwest corner of the building*

It is recommended that the sagging brackets be shored and resupported with reconstructed brackets. The brackets can be built from reinforced wood blocking with tieback straps to stud wall top plates. Alternatively, the brackets can be fitted with a strong top section cantilevering out to the roof edge. This strong top section would need to be extended into the wall approximately 4 feet to offer sufficient anchorage resistance from the weight of at least two other rafters.

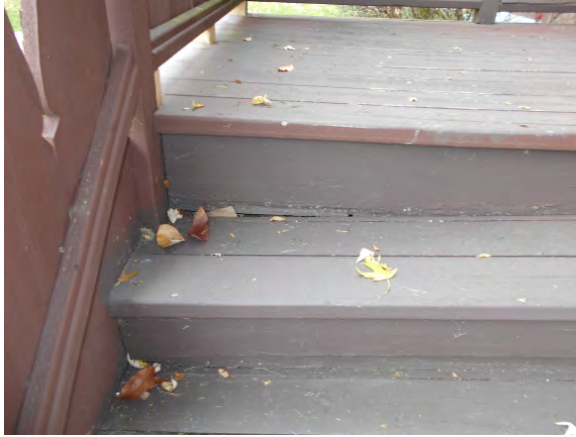
The front and side porches both have issues. The concrete portions appear to be in good condition and functioning. All of the wood components are in need of attention. Many have been repaired or replaced previously. The deck boards and possibly the support members below are deteriorated and in need of at least partial replacement. The steps and railings are in fair condition and need repair. Handrails do not conform to current code.

**Image 1.21**  
*Deteriorated front porch steps*

It is recommended that the front and side porches be repaired. This will require at least partial disassembly. Damaged wood framing should be replaced. Loose railings and posts should be reinforced or replaced.
