JOINT TOURISM COMMISSION AND HISTORIC PRESERVATION COMMISSION  
MEETING MINUTES - DRAFT  
VILLAGE OF NEW GLARUS  
11/13/2018

### Heritage Preservation Consulting, LLC

# Chalet of the Golden Fleece Museum Historic Conditions Report

Observation and commentary offered here are based upon the condition assessments conducted on October 21, 2014. Preservation Architect Charles Quagliana reviewed the exterior elements, Kurt Straus, Structural Engineer, reviewed the structural components and Peggy Veregin, preservation specialist reviewed the interior.

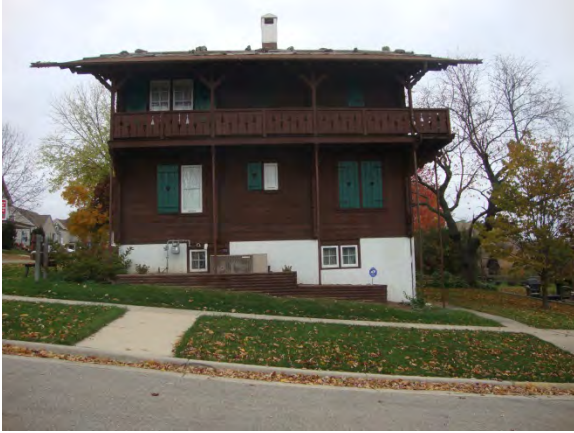
**Image 1.5**

The property slopes downhill approximately eight feet from 2<sup>nd</sup> Street to the rear of the property. The house fronts on 2<sup>nd</sup> Street with the side yard adjoining 7<sup>th</sup> Avenue. The property has been adequately maintained but features little landscape.

*View of the Chalet from 7<sup>th</sup> Avenue showing sloping site*

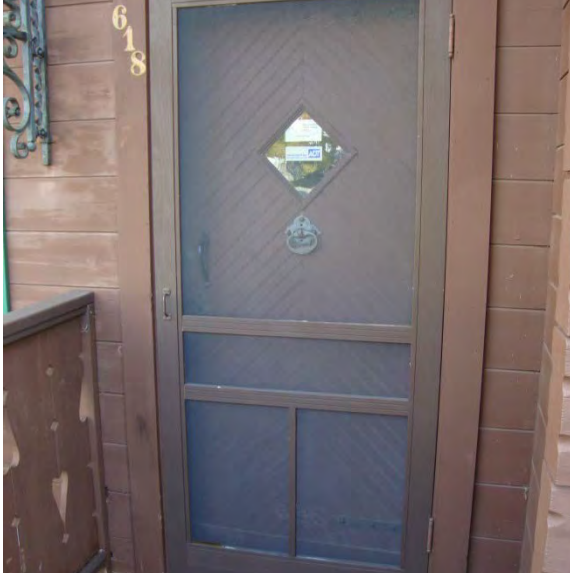
**Image 1.13**  
*View of front door with screen door.*

The wood front and side entrance doors appear to be original and are in good condition. These are serviceable and durable and have weather stripping and adequate hardware. The side porch door has a broken surface mounted interior lock. The screen doors at these locations are in good condition with minor screen repairs required. The second floor balcony door is also original and in good condition. This door scrapes the interior floor when opened but otherwise is survivable. The related screen door is in good condition. The rear door at the basement is not original (based upon the original drawings) but in good condition. It does have several deteriorated diagonal boards. It does not have a screen door.

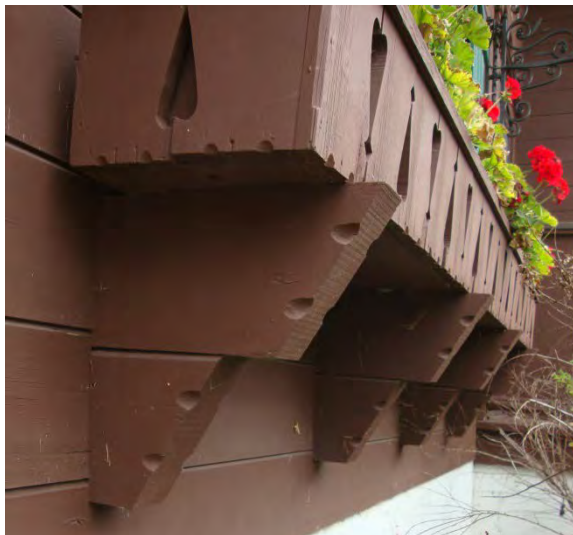
**Image 1.14**  
*Front window box and bracket*

The window boxes are a traditional element of the Chalet revival style of residential architecture. These were originally created to romanticize the picturesque alpine locations of the prototype chalets. The window boxes on the chalet are well built with galvanized liners and sturdy support brackets. These are in good overall condition with some deterioration due to age and weather exposure. The brackets appear to be functioning adequately.

and all boxes and brackets should be scraped primed and painted. Automatic watering systems at the second floor should be evaluated and reconnected.
